Environmental Noise Assessment

TopGolf Noise Monitoring Survey

Roseville, CA

November 21, 2016

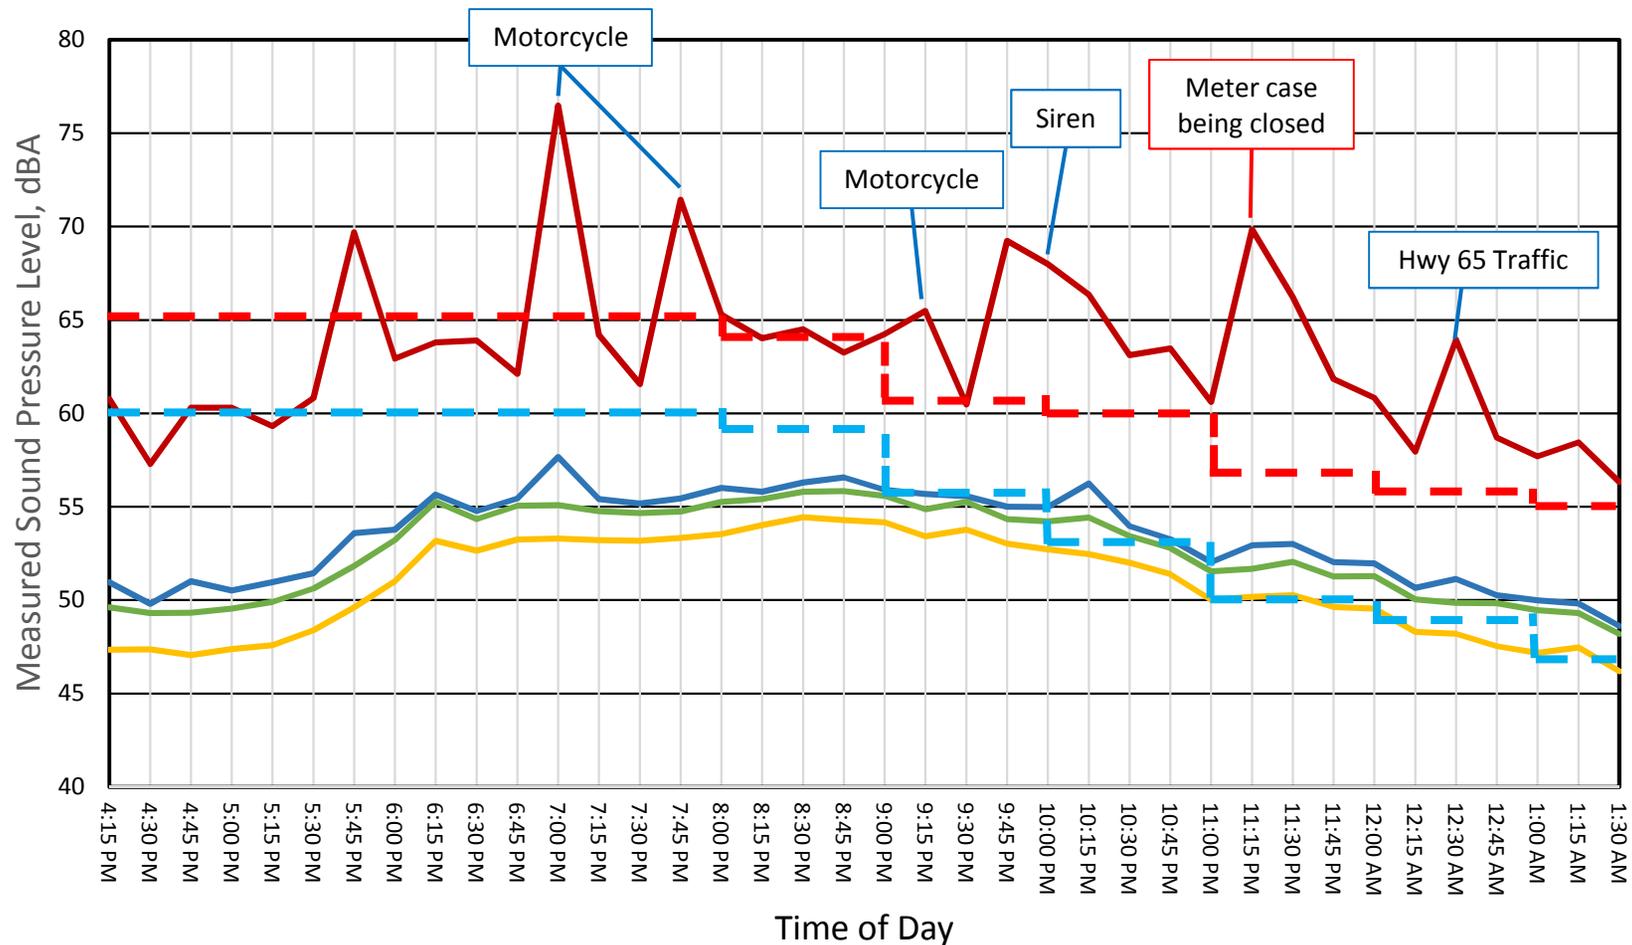
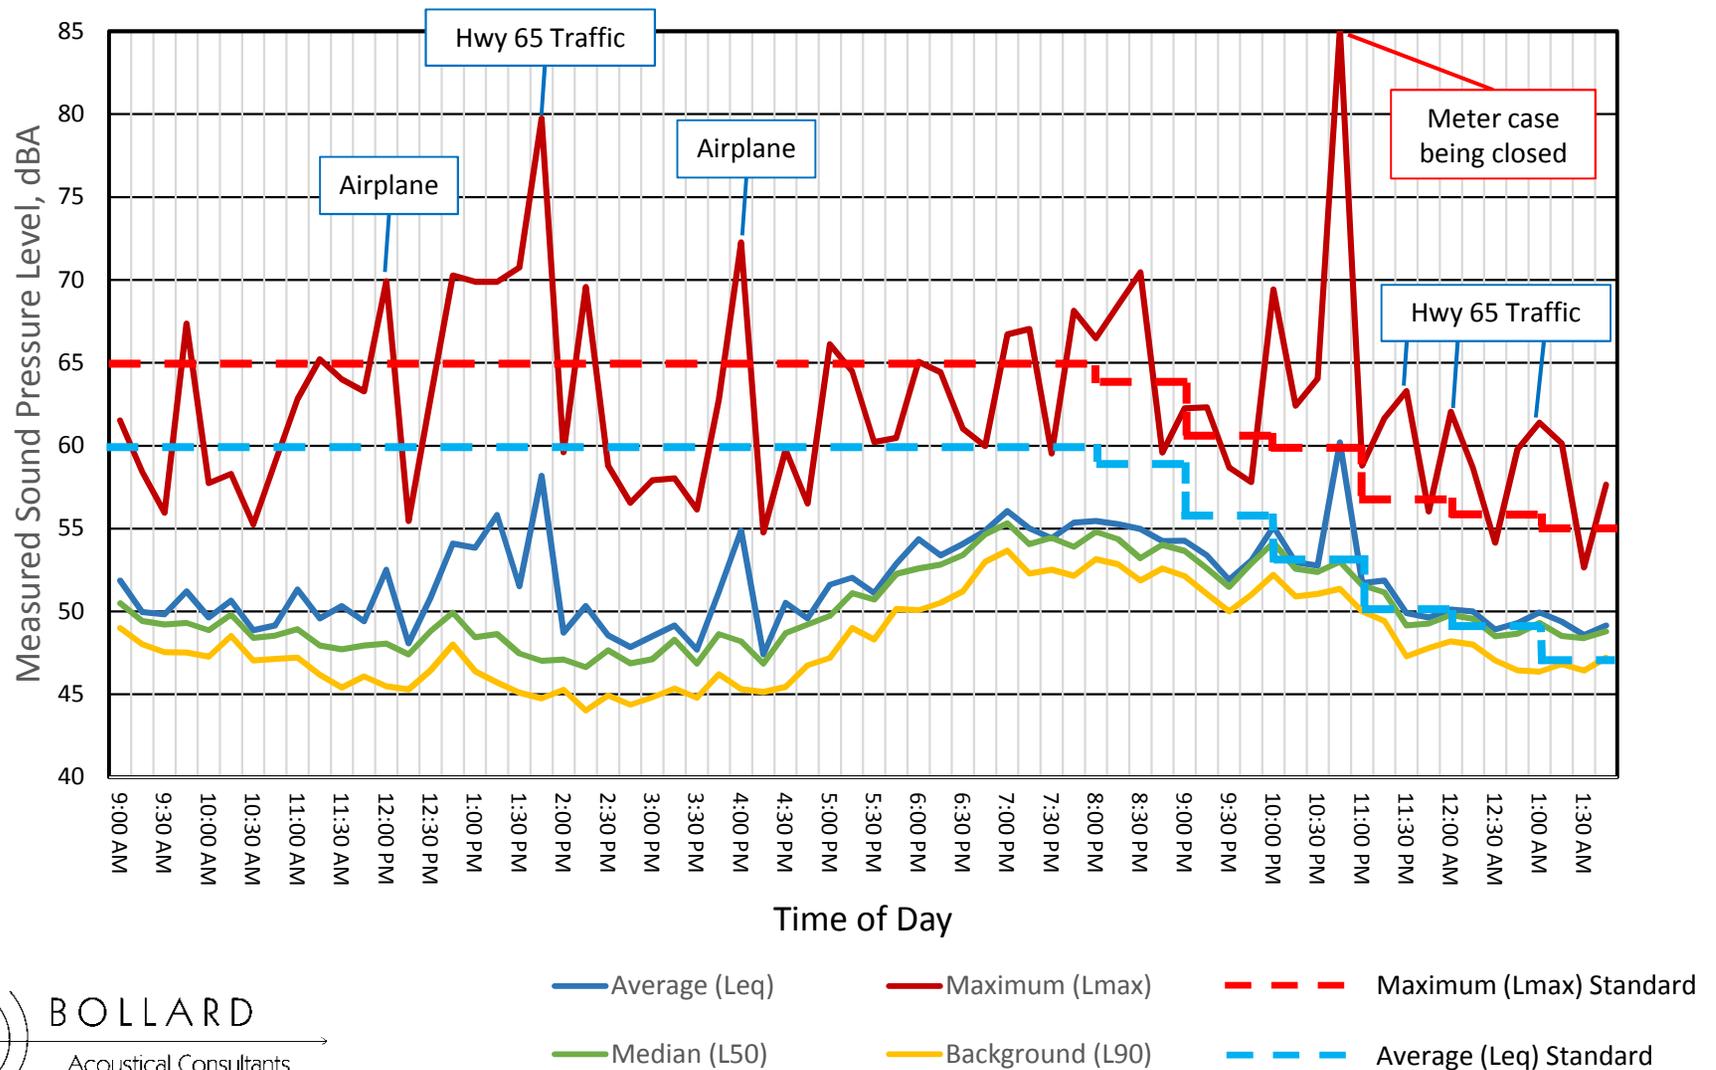
Examination of the noise level data for Measurement Site 1, shown in Appendices C1 and C2, indicates that, while measured maximum noise levels exceeded the Topgolf L_{max} thresholds during various times of the day and night, those exceedances were caused by aircraft, sirens, Washington Boulevard and Highway 65 traffic, and other sources. Noise from Topgolf operations was not identified as resulting in exceedance of the L_{max} thresholds. Even during the late night hours when traffic noise levels were lower.

Measured average noise levels at Site 1 were also above the Topgolf L_{eq} thresholds from approximately 10 pm on Friday night, but not on Saturday night. However, BAC staff observations conducted during the late-night hours indicated that noise from Topgolf music and patrons was completely inaudible at measurement Site 1 during the late-night hours. As a result, it was concluded that Topgolf operations were well within compliance with the project L_{eq} noise thresholds at Site 1.

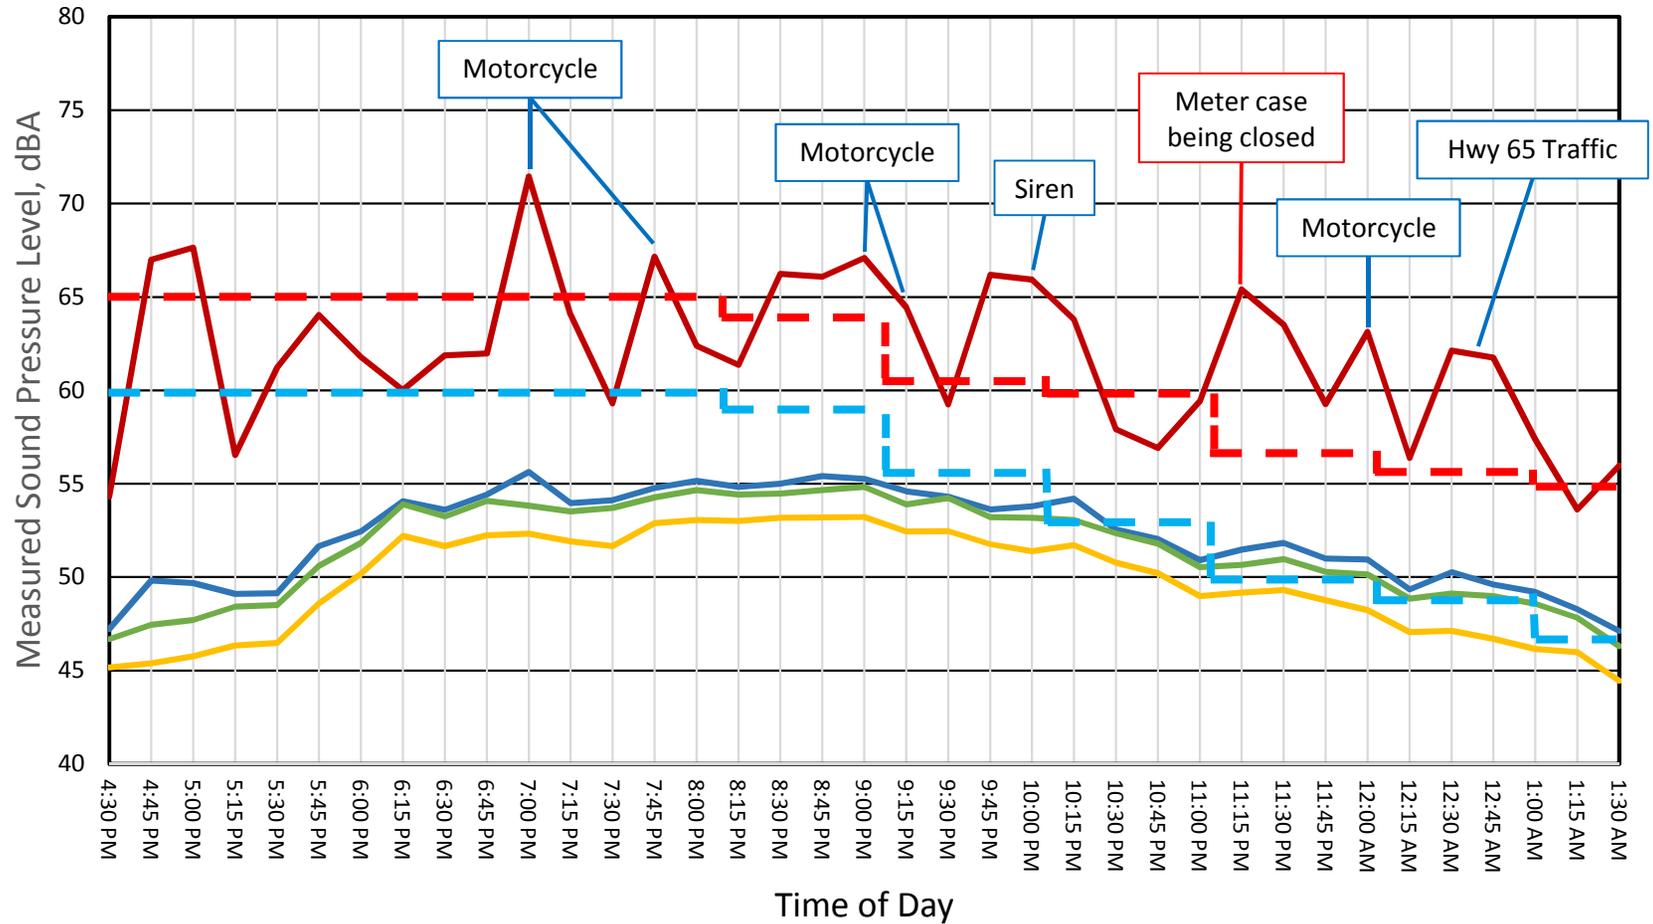
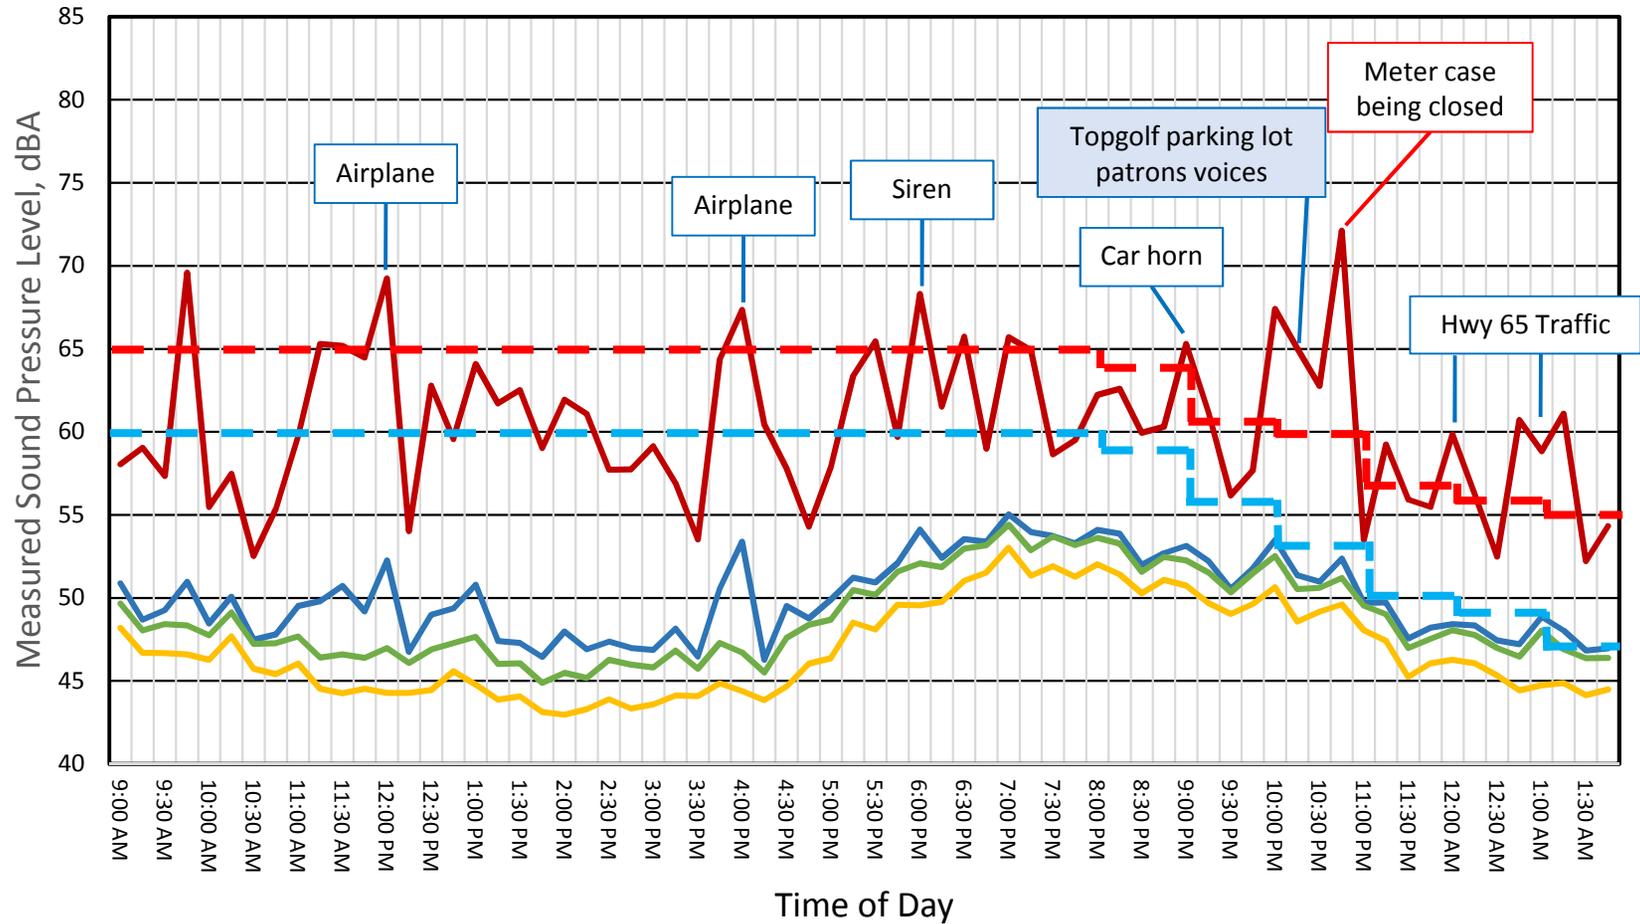
Examination of the noise level data for Measurement Site 2, shown in Appendices C3 and C4, indicates that, while measured maximum noise levels exceeded the Topgolf L_{max} thresholds during various times of the day and night, those exceedances were caused by aircraft, sirens, Washington Boulevard and Highway 65 traffic, and other sources. Although not the main noise source, noise from Topgolf operations was identified as resulting in an exceedance of the 60 dB L_{max} standard during a brief period of Topgolf patrons talking in raised voices in the parking lot area around 10:15 pm on Saturday. The measured exceedance was 5 dB above the noise level standard.

Measured average noise levels at Site 2 were also above the Topgolf L_{eq} thresholds from approximately 10 pm on Friday night, but not on Saturday night. However, BAC staff observations conducted during the late-night hours indicated that noise from Topgolf music and patrons was virtually inaudible at measurement Site 2 during the late-night hours (with the exception of the noted maximum noise standard exceedance noted above). Observed average noise levels resulting from Topgolf operations were below the City's noise thresholds applied to the project at measurement site 2.

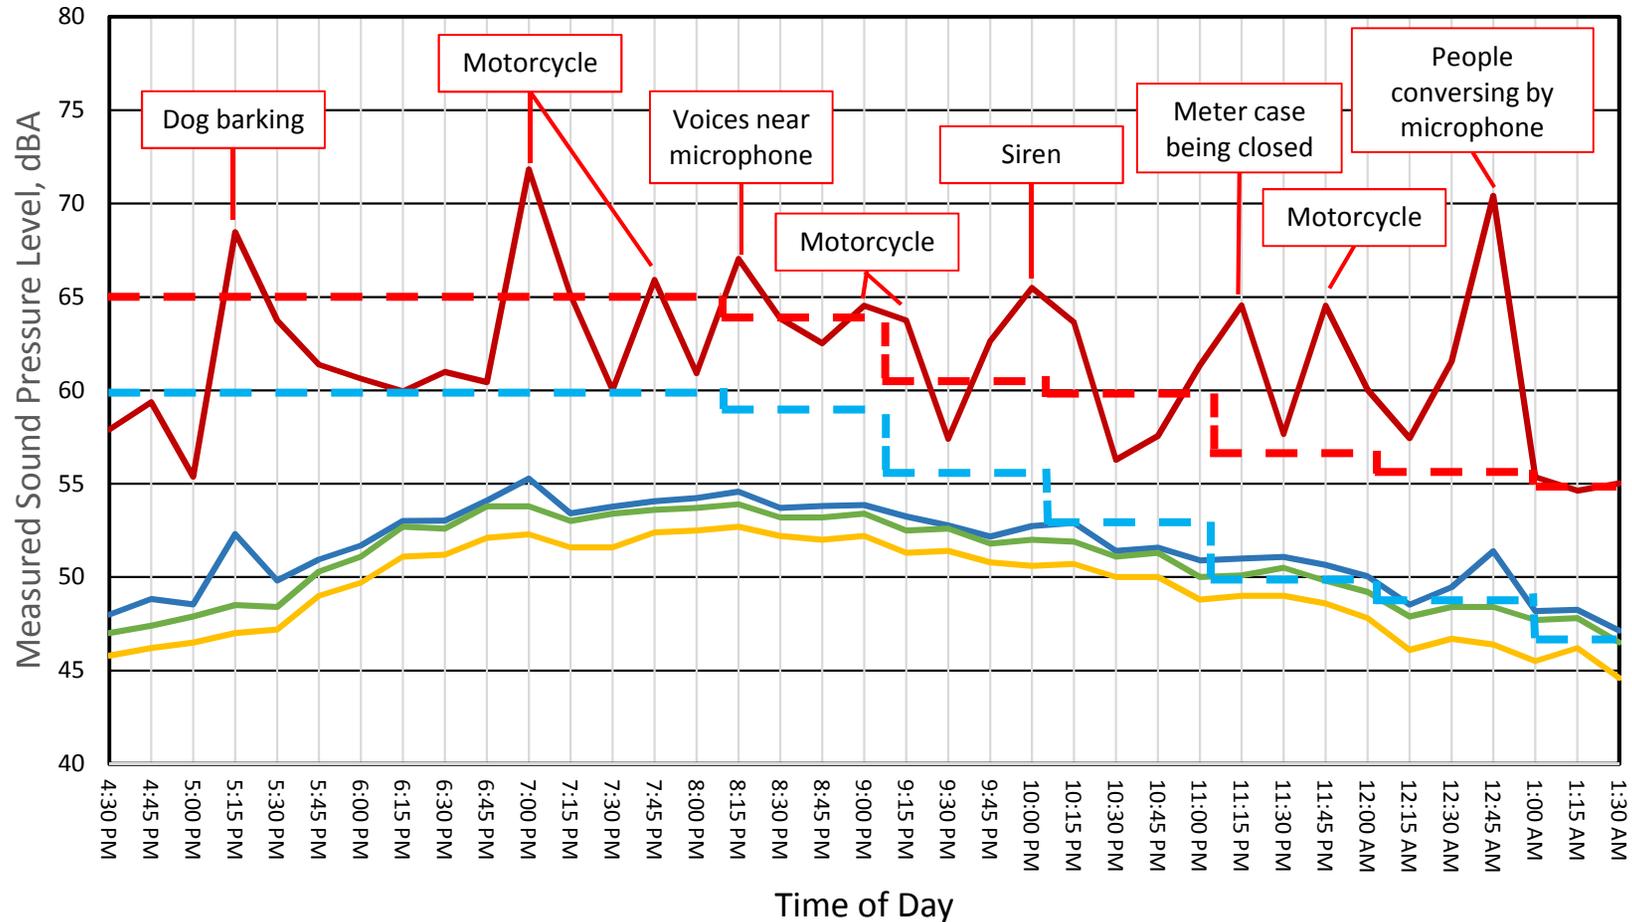
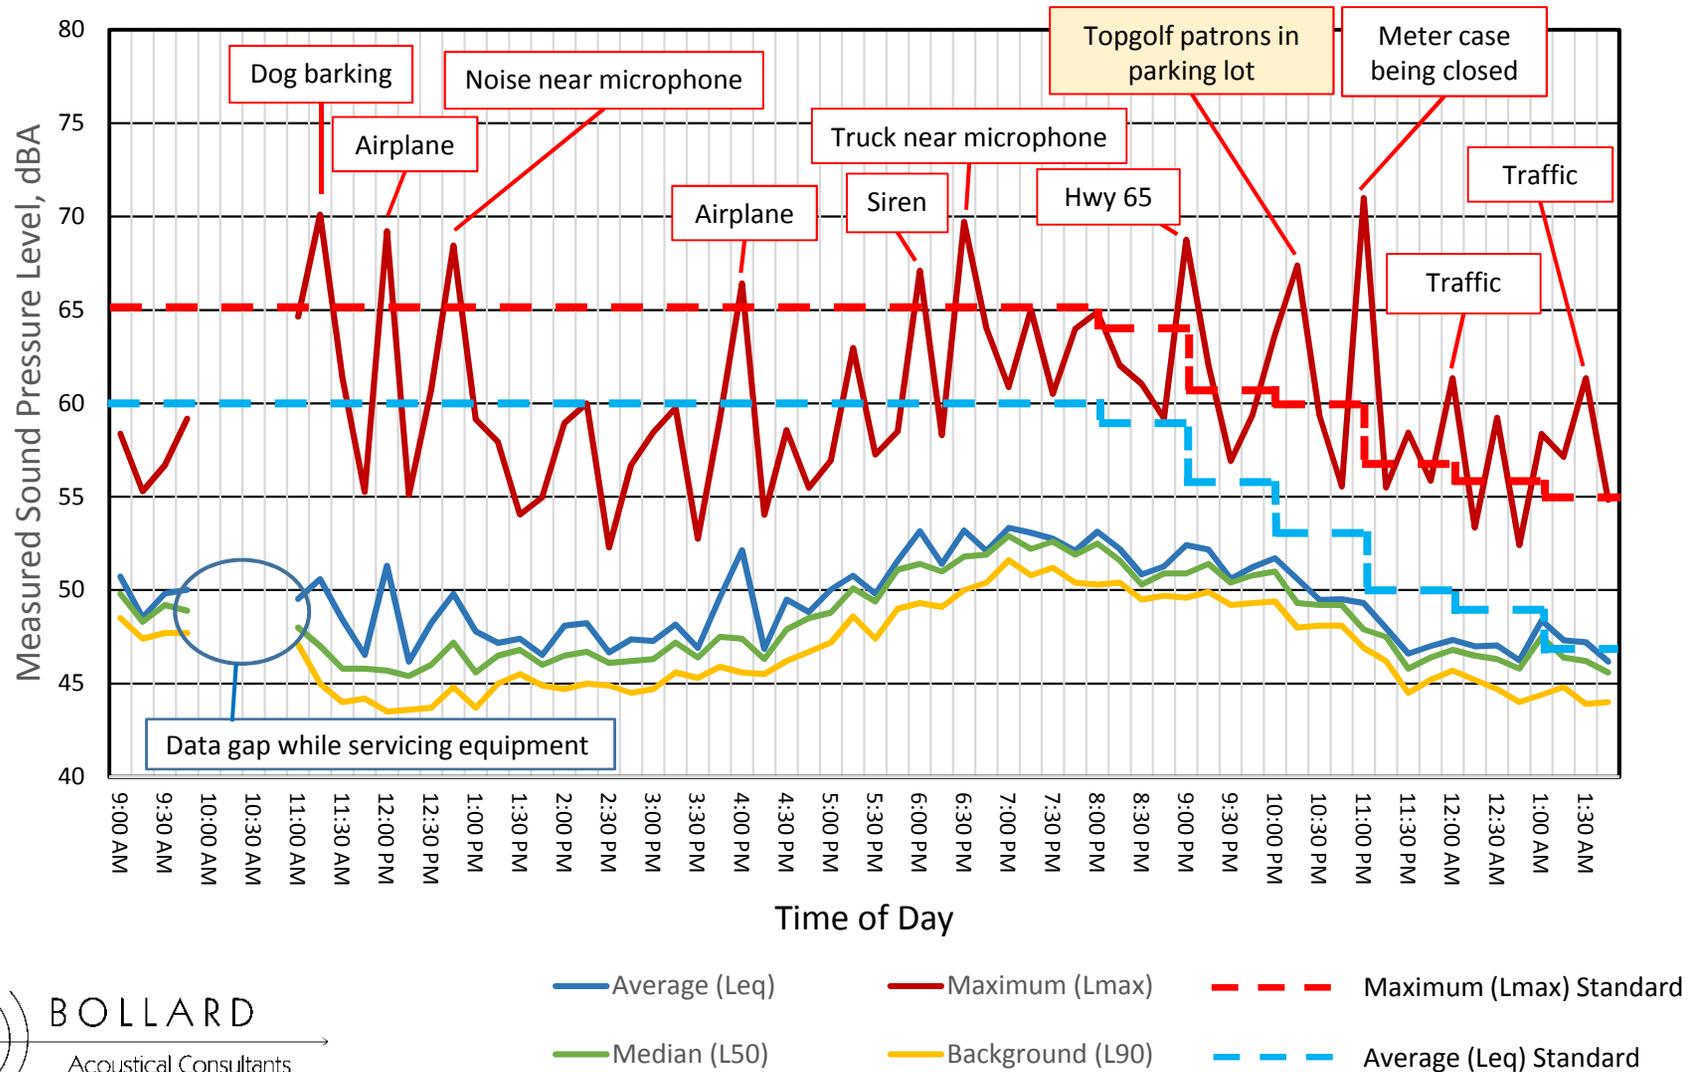
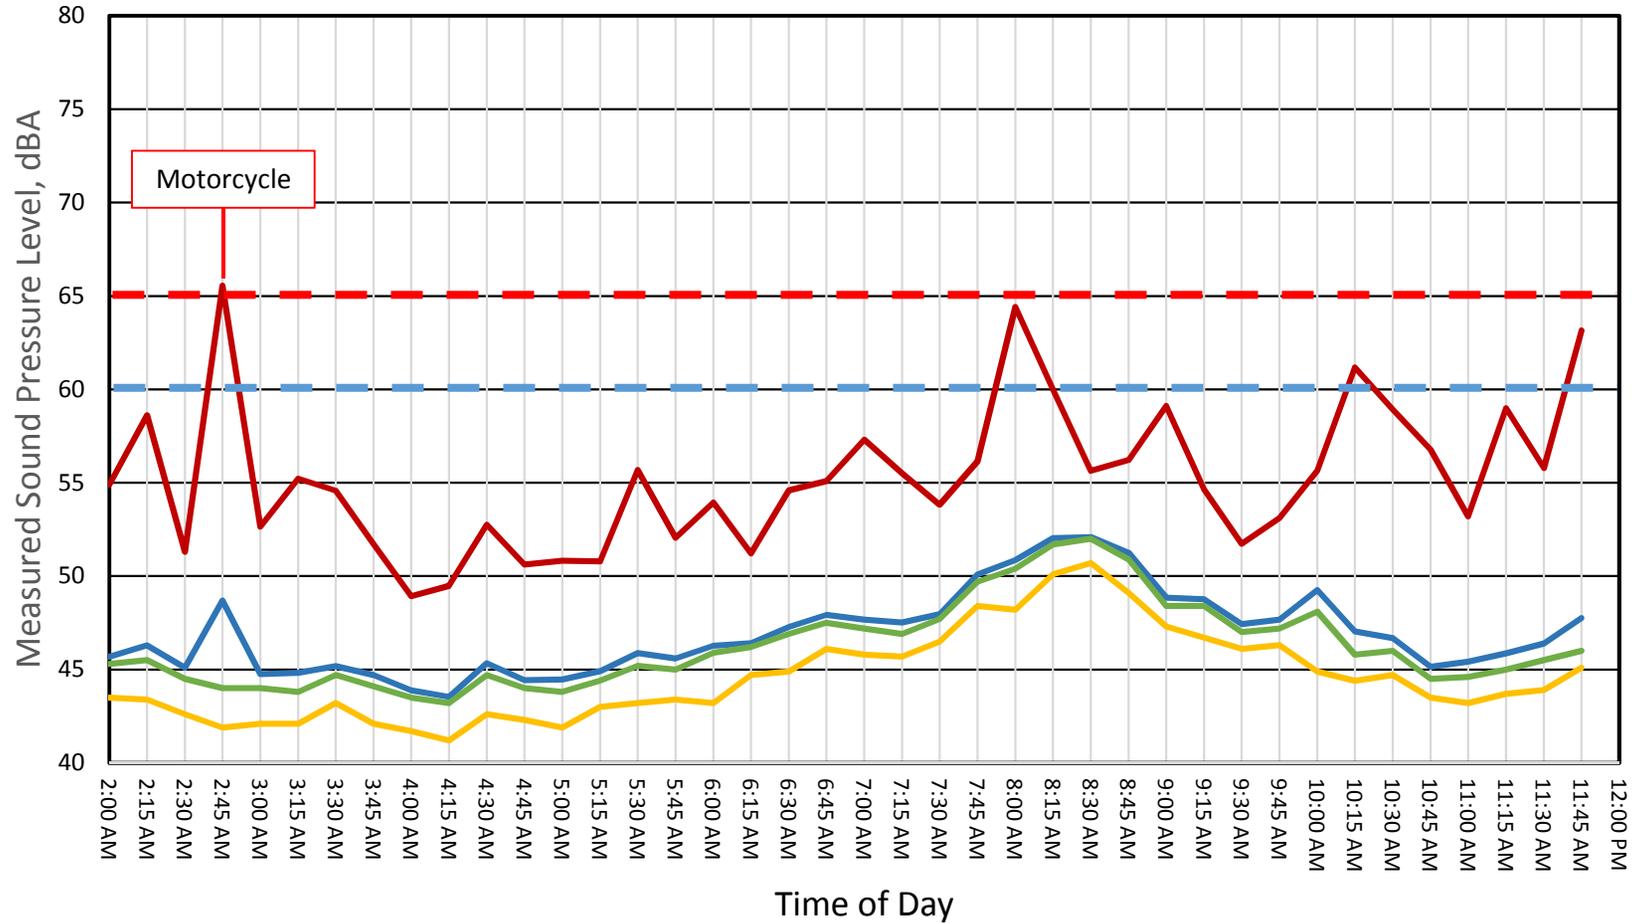
Measurement Site 3 was located closest to the main Topgolf parking area, but was shielded from view of the open drive bays. Examination of the noise level data for Measurement Site 3, shown in Appendices C5 - C7, indicates that, while measured maximum noise levels exceeded the Topgolf L_{max} thresholds during various times of the day and night, those exceedances were caused by aircraft, sirens, Washington Boulevard and Highway 65 traffic, and other sources. Although not the main noise source, noise from Topgolf operations was identified as resulting in an exceedance of the 60 dB L_{max} standard during a brief period of Topgolf patrons talking in raised voices in the parking lot area around 10:15 pm on Saturday. This is the same exceedance which was identified at measurement Site 2. The measured exceedance was 7 dB above the noise level standard at measurement Site 3.

Measured average noise levels at Site 3 which were attributable to Topgolf, and not Highway 65 traffic, were below the project's average (L_{eq}) noise thresholds during the entire noise monitoring period. The spike in the measured L_{eq} value at 12:45 am on Saturday morning was due to people talking in close proximity to the microphone, well away from the Topgolf parking area and driving range. After isolating Topgolf noise sources at this location, it was determined that average noise levels resulting from those operations were within compliance with the project's average noise standards.

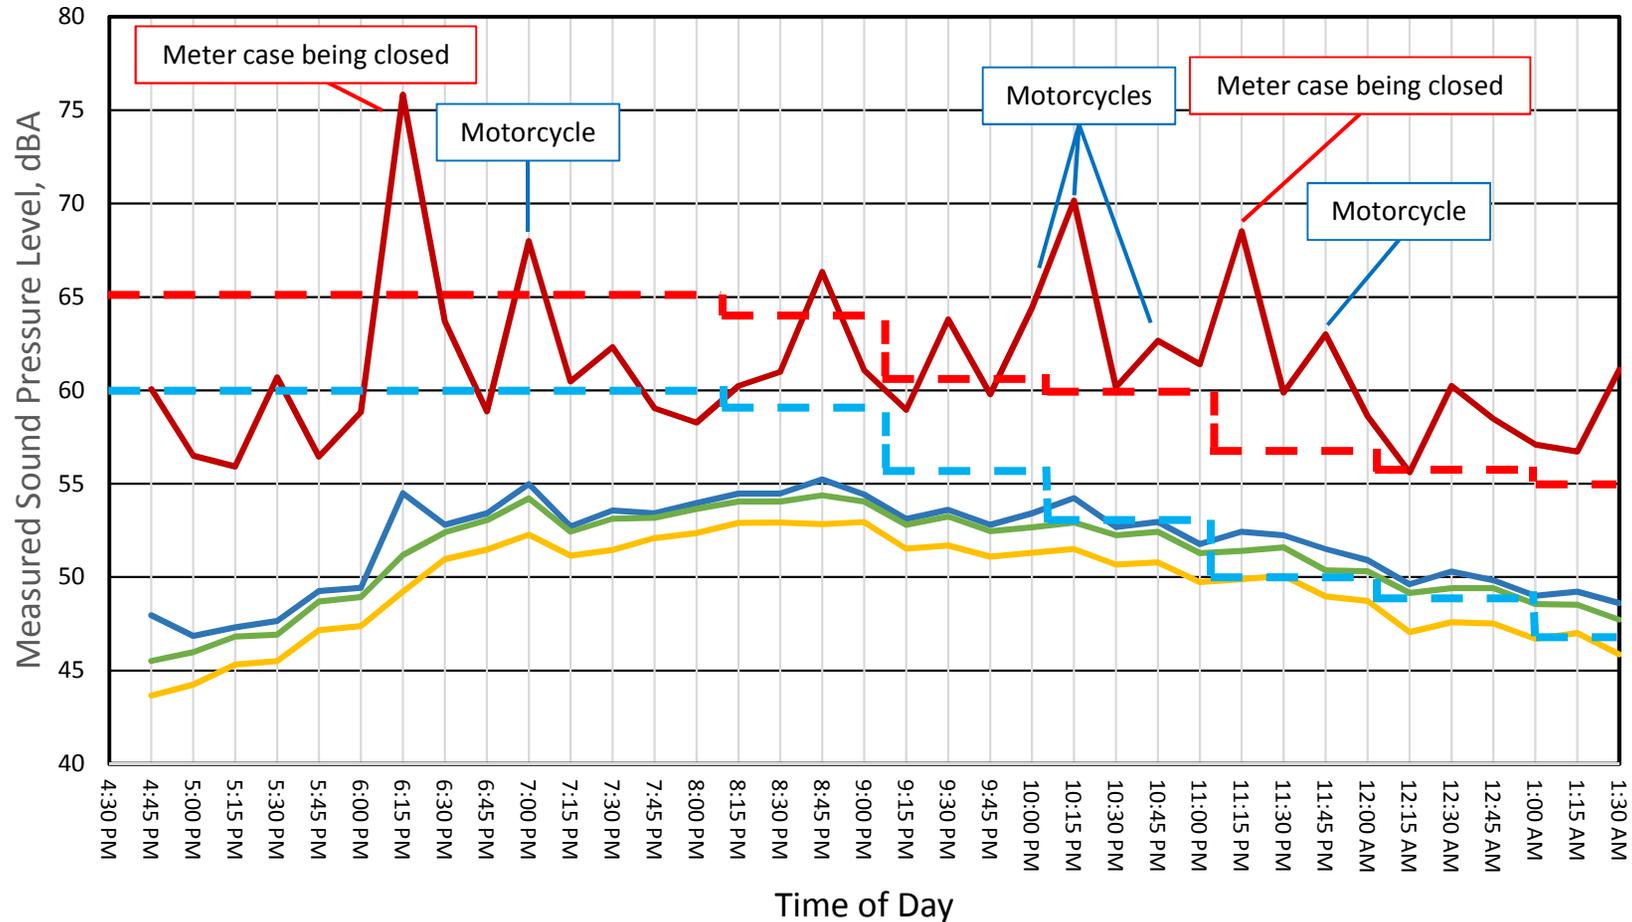
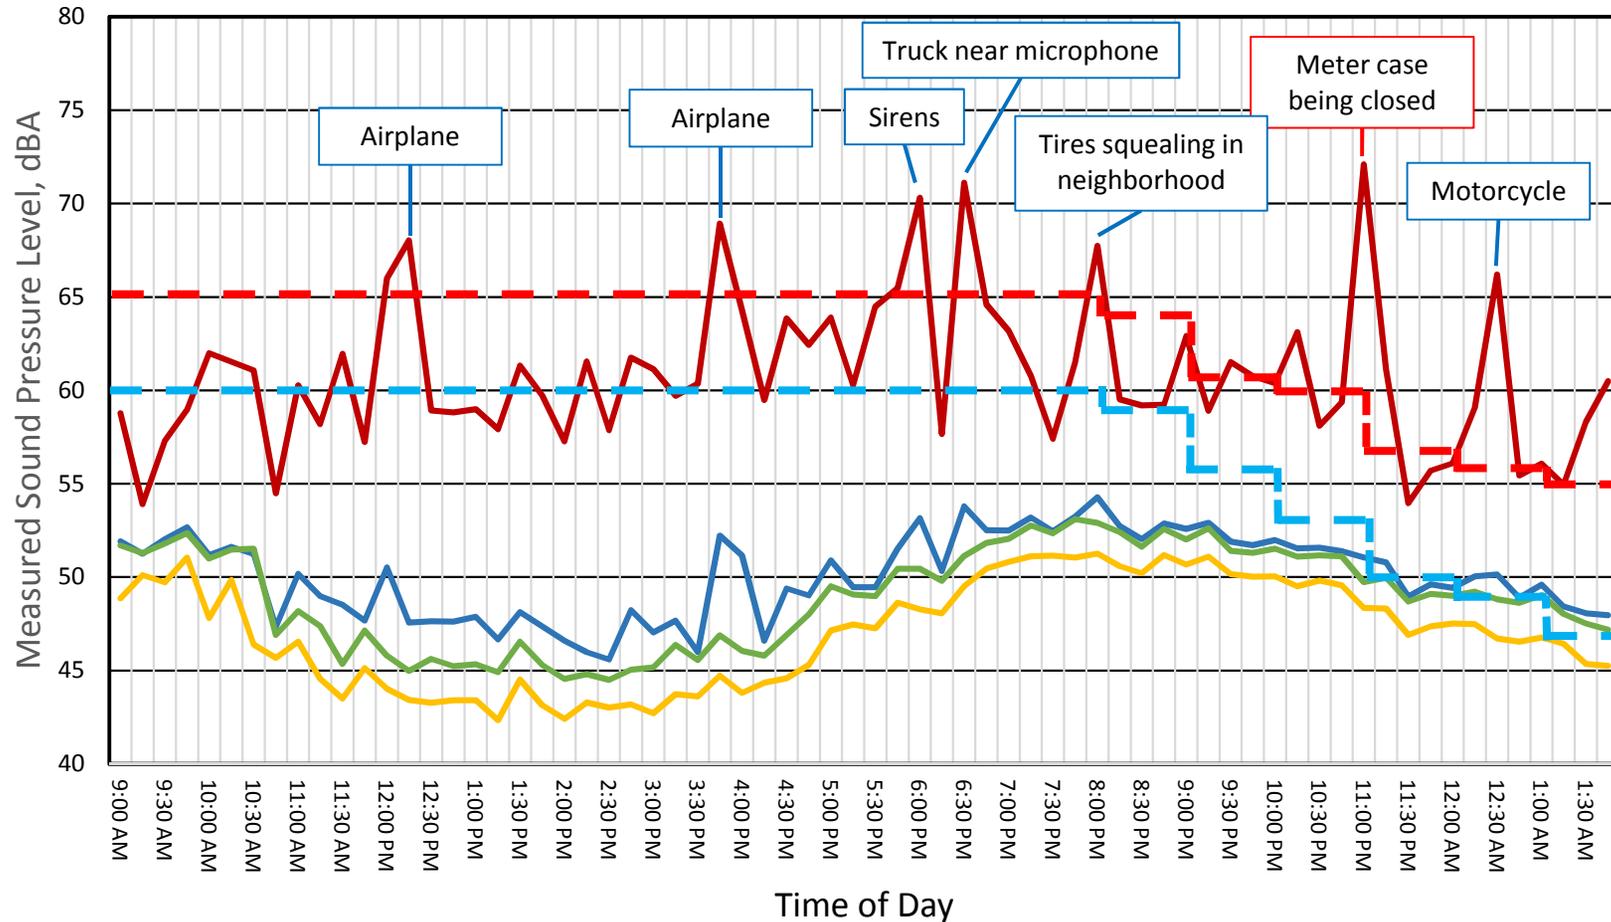
Measurement Site 4 was located at the closest point to the Topgolf structure, but the open driving range bays were blocked from view by the structure. Examination of the noise level data for Measurement Site 4, shown in Appendices C8 and C9, indicates that, while measured maximum noise levels exceeded the Topgolf L_{max} thresholds during various times of the day and night, those exceedances were caused by aircraft, sirens, Highway 65 traffic, local traffic and other sources not attributable to Topgolf operations. Maximum noise levels from Topgolf operations were identified as being within compliance with the project's maximum noise level standards at Site 4.

Measured average noise levels at Site 4 which were attributable to Topgolf, and not Highway 65 traffic or other local noise sources, were below the project's average (L_{eq}) noise thresholds during the entire noise monitoring period.

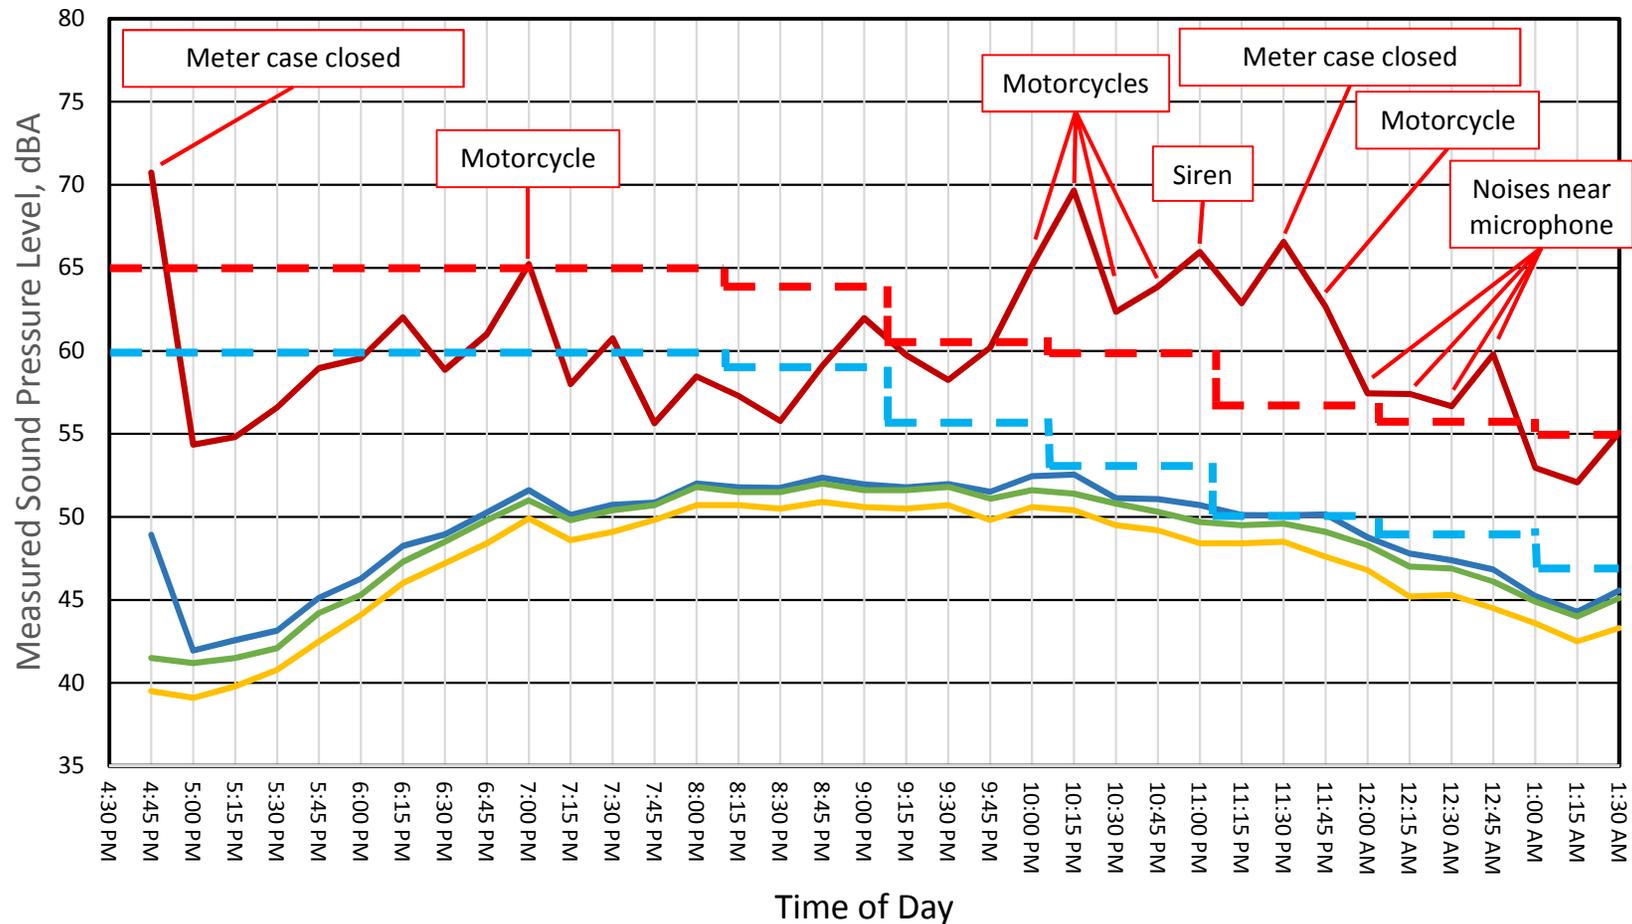
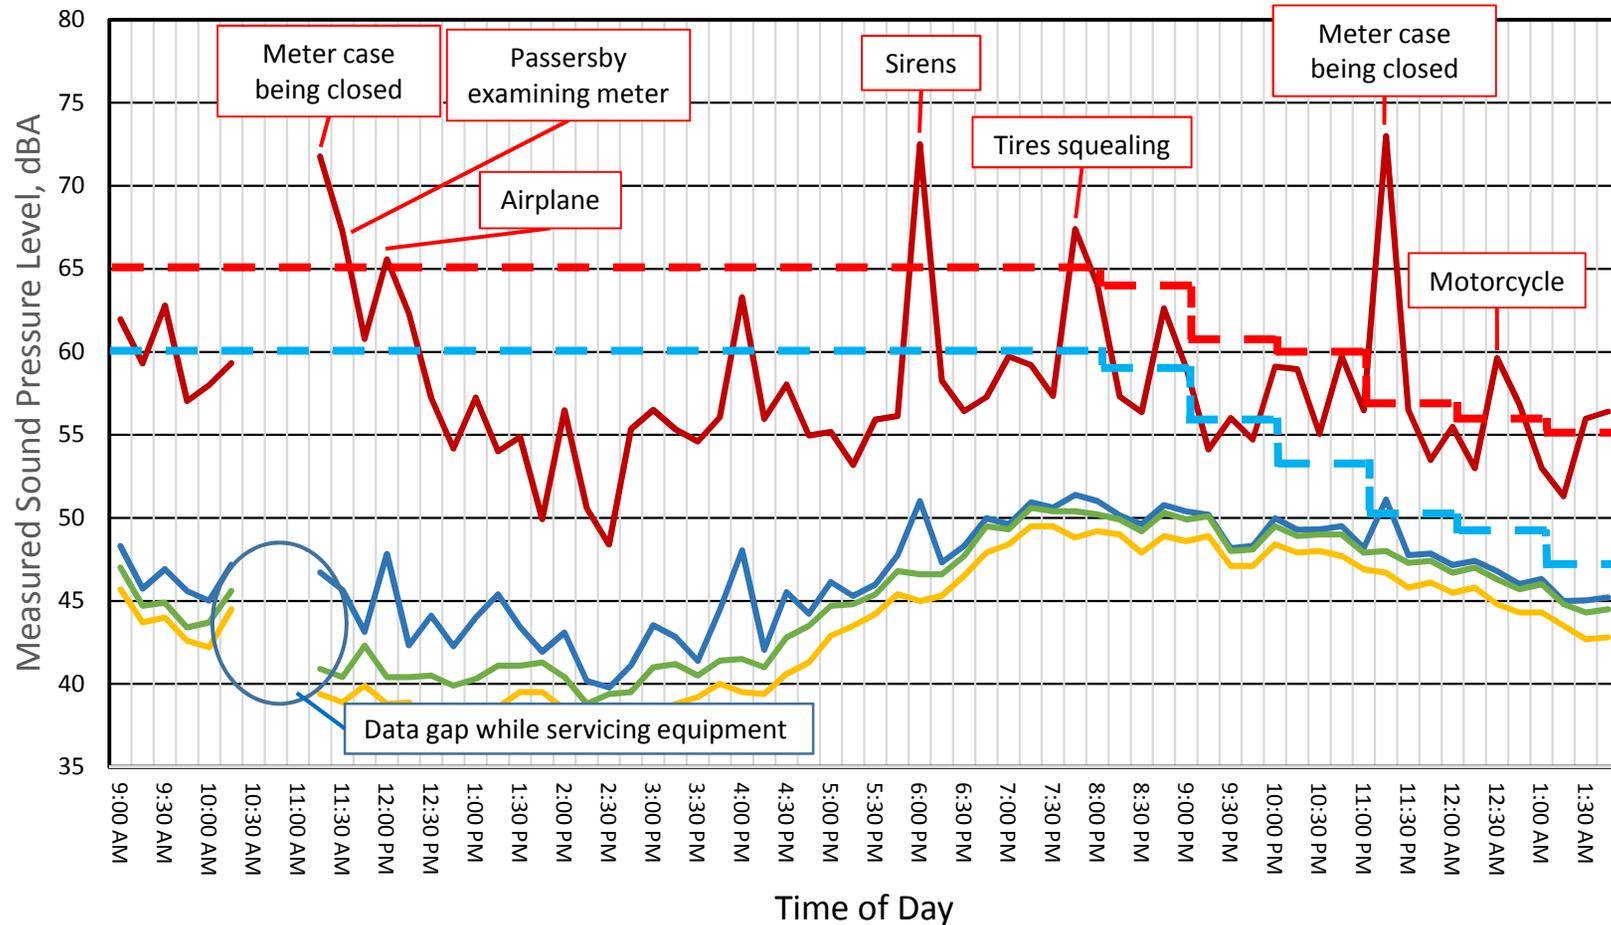
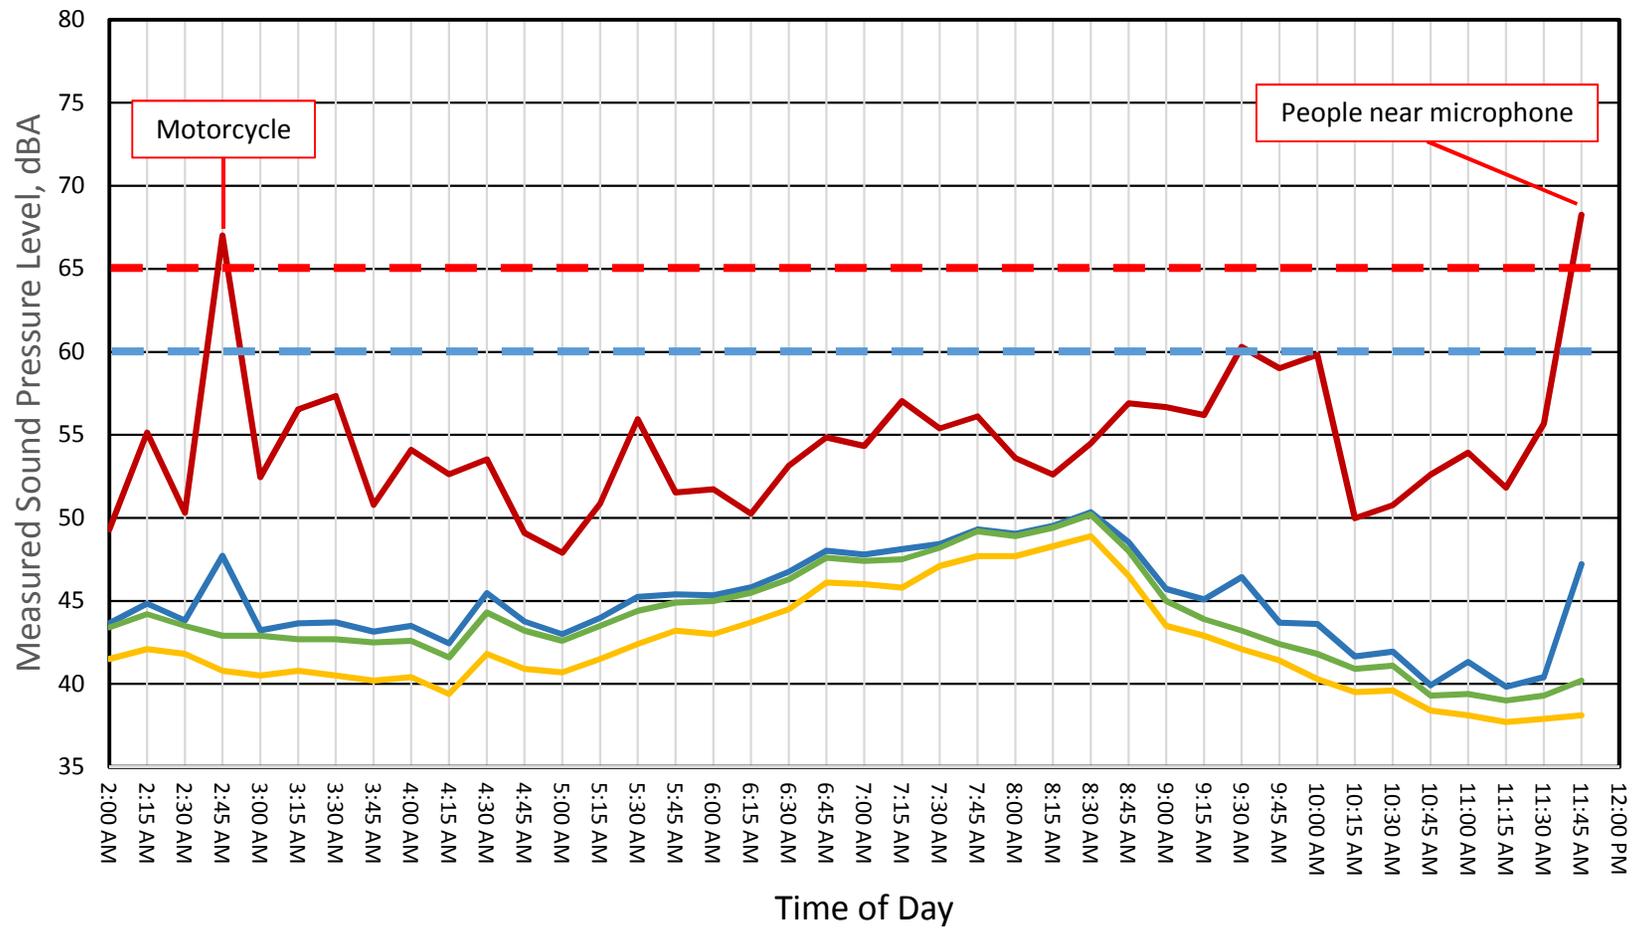
Measurement Site 5 was the closest noise measurement site to the open drive bays, and had full view of those bays. Examination of the noise level data for Measurement Site 5, shown in Appendices C10 and C11, indicates that, while measured maximum noise levels exceeded the Topgolf L_{max} thresholds during various times of the day and night, those exceedances were caused by aircraft, sirens, Highway 65 traffic, local traffic and other sources not attributable to Topgolf operations. Maximum noise levels from Topgolf operations were identified as being within compliance with the project's maximum noise level standards at Site 5.

It should be noted that both music and Topgolf patron voices were audible at measurement Site 5. However, average noise levels reported in Appendices C10 and C11 were below the project's L_{eq} thresholds even when added to existing Highway 65 traffic noise. As a result, no exceedance of the project's average noise thresholds were registered at the measurement Site 5, despite that location being the closest to the open drive bays.
