Environmental Noise Assessment

TopGolf Noise Monitoring Survey

Roseville, CA

November 21, 2016

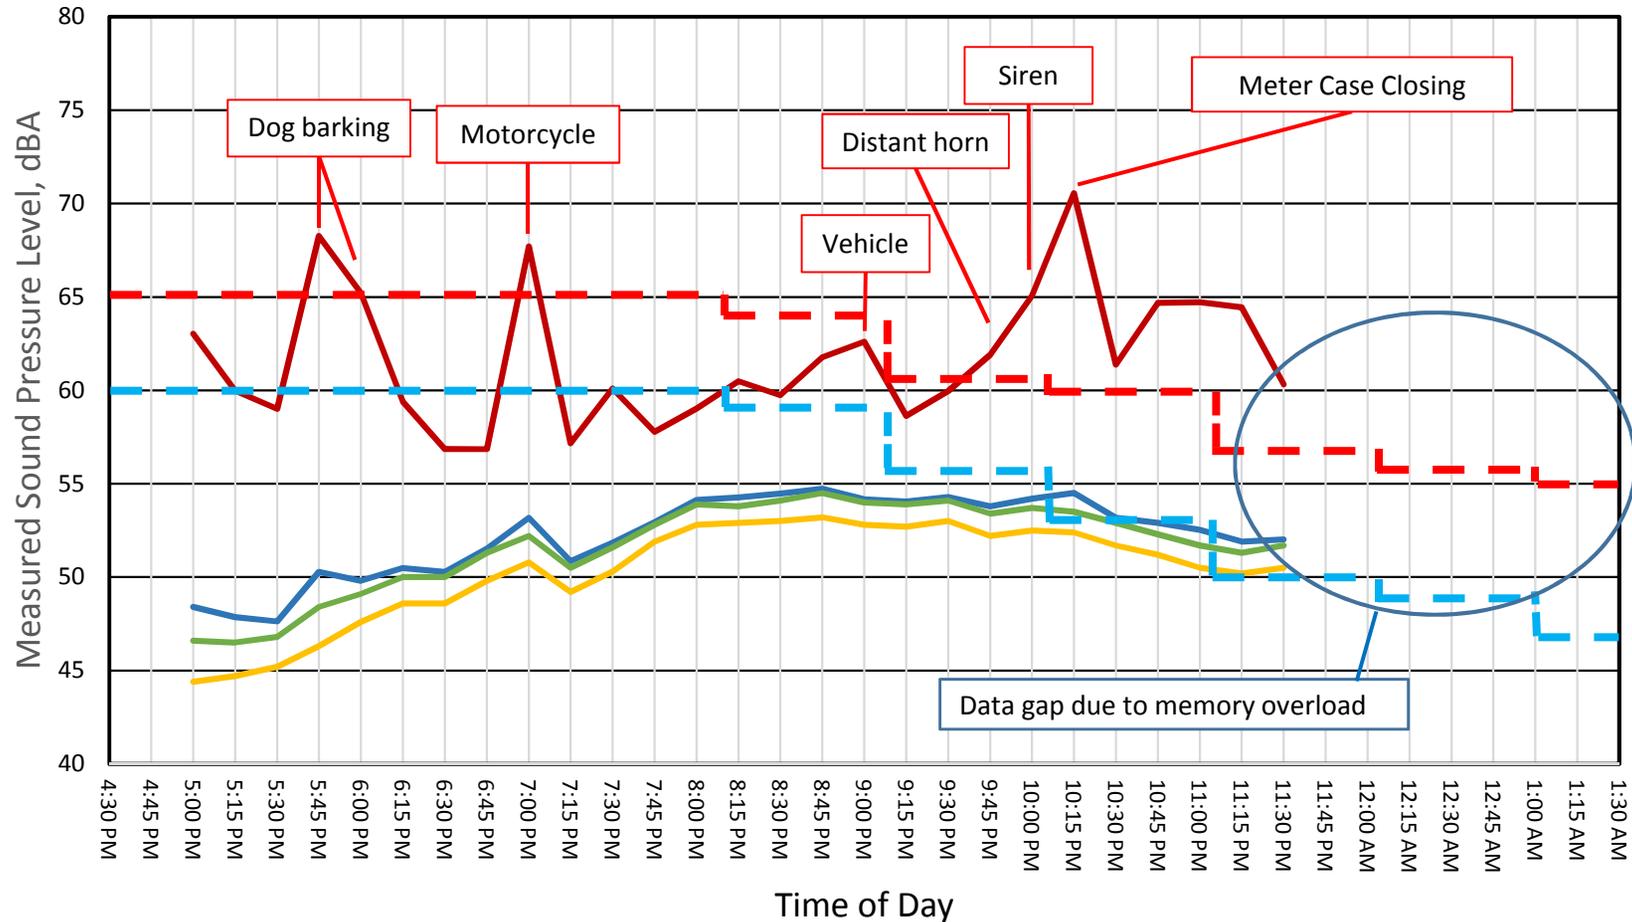
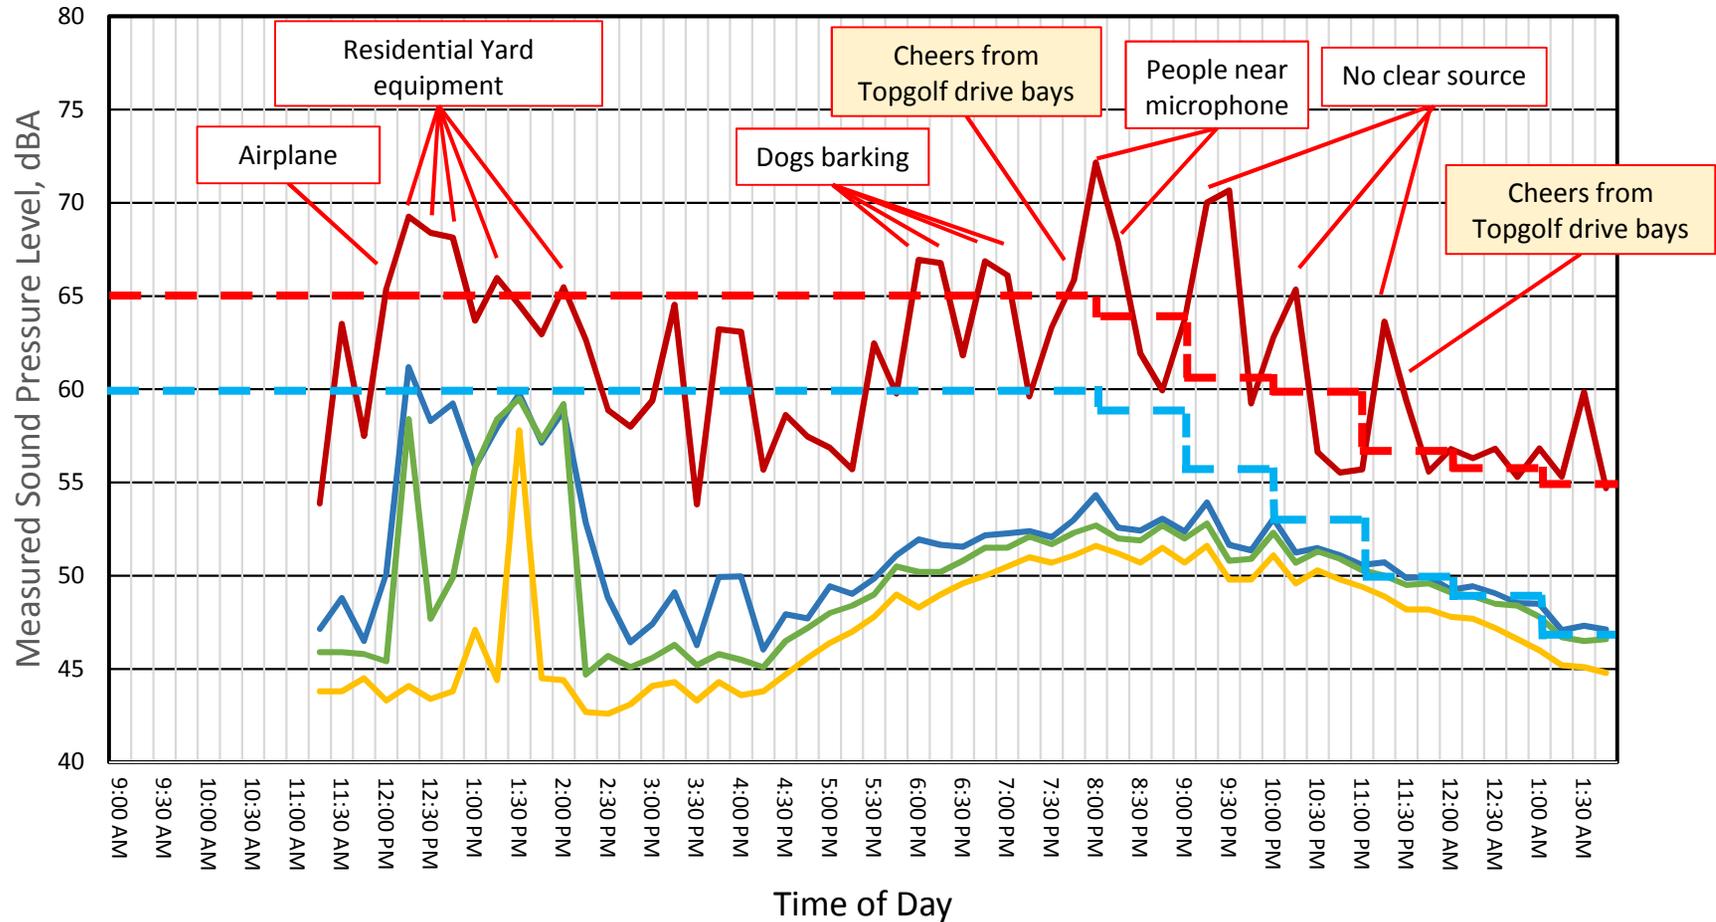
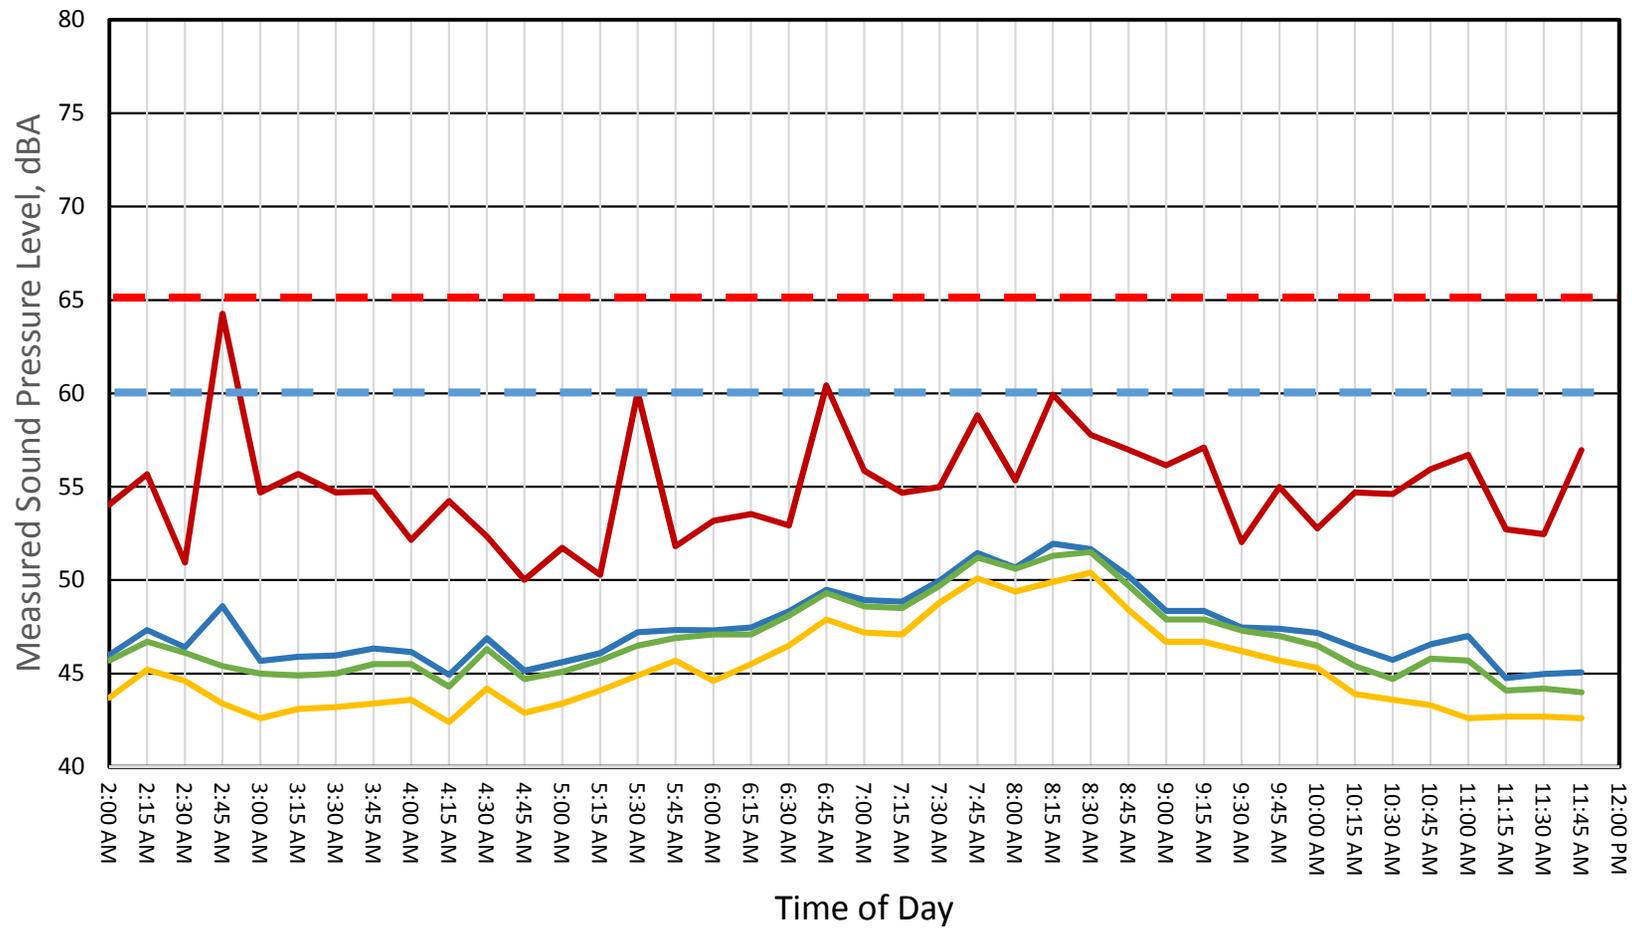
Examination of the noise level data for Measurement Site 6, shown in Appendices C13 through C15 indicates that, while measured maximum noise levels exceeded the Topgolf L_{max} thresholds during various times of the day and night, with two exceptions those exceedances were caused by aircraft, sirens, Washington Boulevard and Highway 65 traffic, and other sources. Although not the main noise source, noise from cheering Topgolf patrons was identified as resulting in an exceedance of the 65 dB L_{max} standard at 7:45 pm and exceedance of the 57 dB L_{max} standard at 11:30 pm. The measured exceedances were 1 and 6 dB above the noise level standards, respectively.

Measured average noise levels at Site 6 were also above the Topgolf L_{eq} thresholds from approximately 10 pm on Friday night and 11 pm on Saturday night. However, BAC staff observations conducted during the late-night hours indicated that noise from Topgolf music and patrons was low at Site 6, and within compliance with the project's average noise level standards. By comparison, Appendix C-14 shows that noise generated during neighborhood yard maintenance activities generated average noise levels of approximately 60 dB L_{eq} at measurement Site 6, whereas Topgolf noise was observed to be less than 50 dB during the same period.

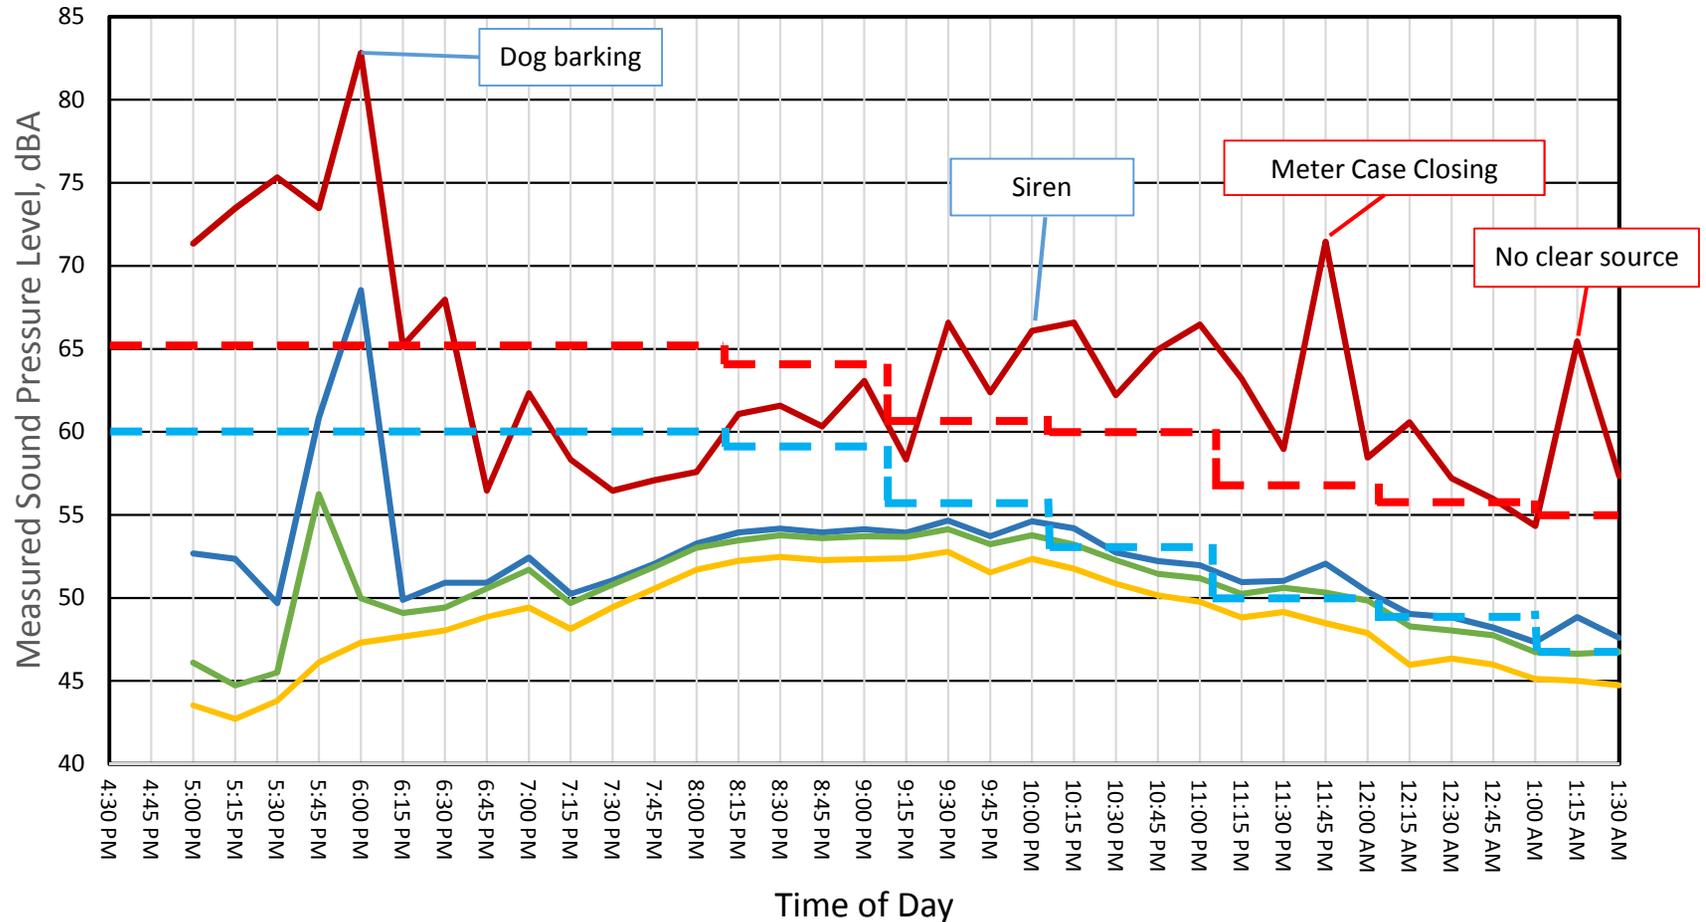
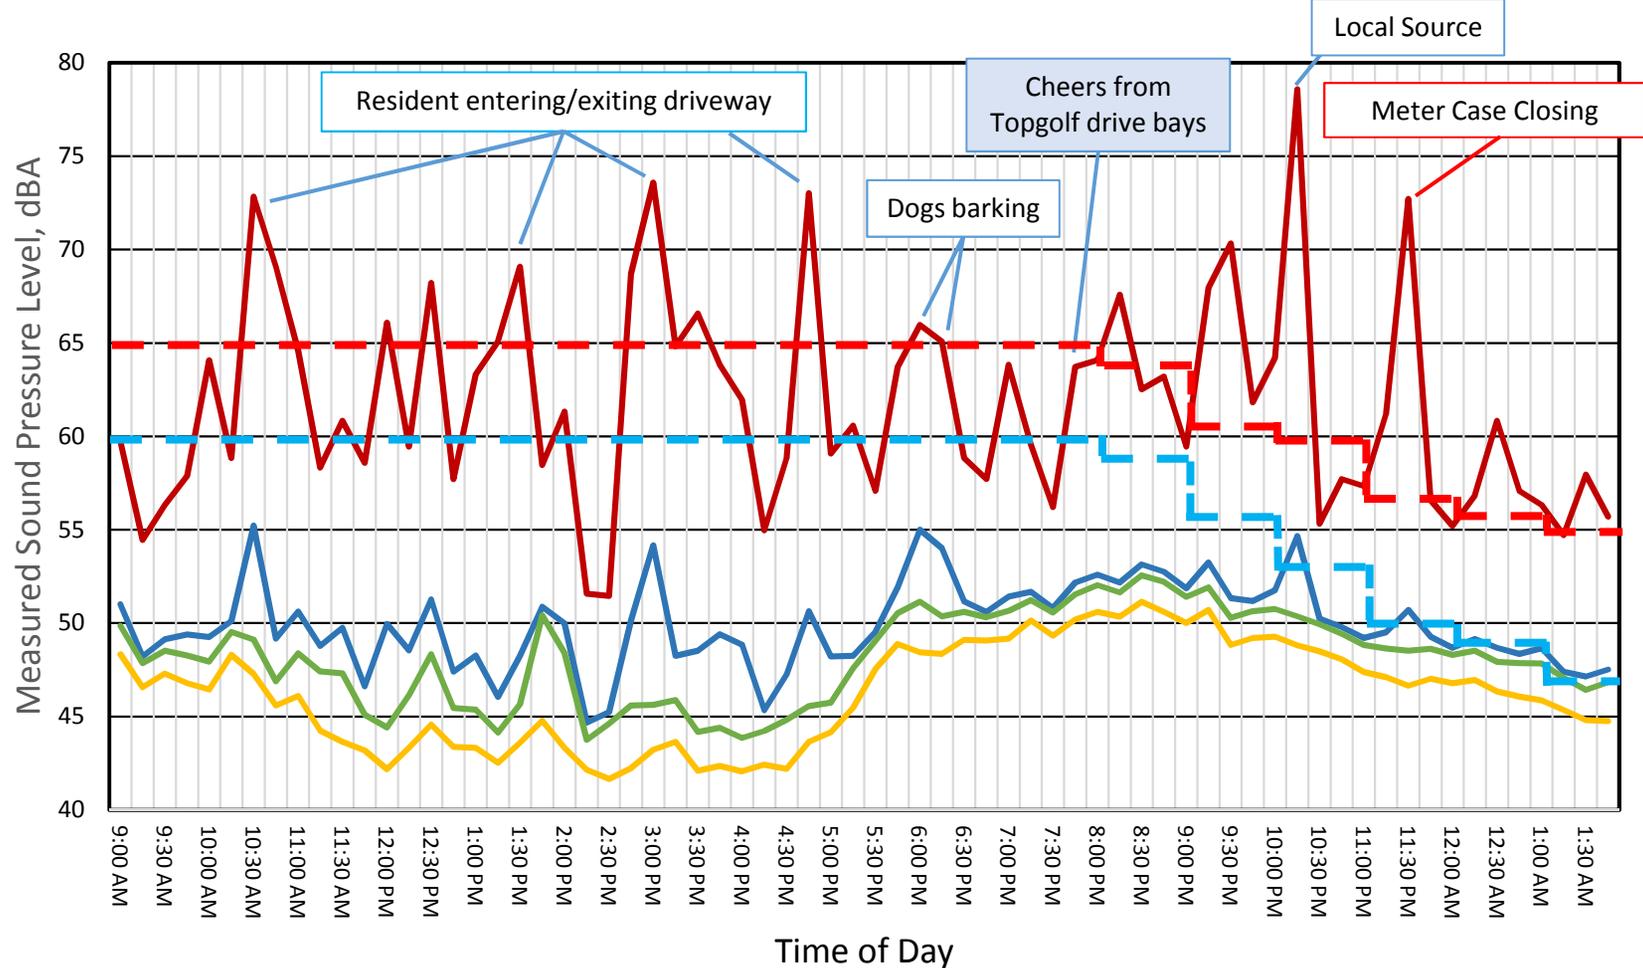
Measurement Site 7 was located at the south end of the adjacent residential development, as indicated in Figure 1. Because the driveway of the adjacent residence was approximately 25 feet from the microphone, the resident arriving and departing his property resulted in several exceedances of the noise standard applied to Topgolf. However, in no case were Topgolf operations observed or identified as having resulted in exceedance of the L_{max} standards applicable to Topgolf operations at Site 7. At 7:45 pm on Saturday night, a cheer from the Topgolf patrons in a drive bay was registered, but it was measured to be 2 dB below the L_{max} threshold applicable to Topgolf operations.

Measured average noise levels at Site 7 were measured as slightly exceeding the Topgolf L_{eq} thresholds during some periods after 10 pm on Friday and Saturday nights. However, BAC staff observations conducted during the late-night hours indicated Topgolf music and patrons were not responsible for those exceedances, and that Topgolf noise was within compliance with the project's average noise level standards at Site 7.
