Environmental Noise Assessment

TopGolf Noise Monitoring Survey

Roseville, CA

November 21, 2016

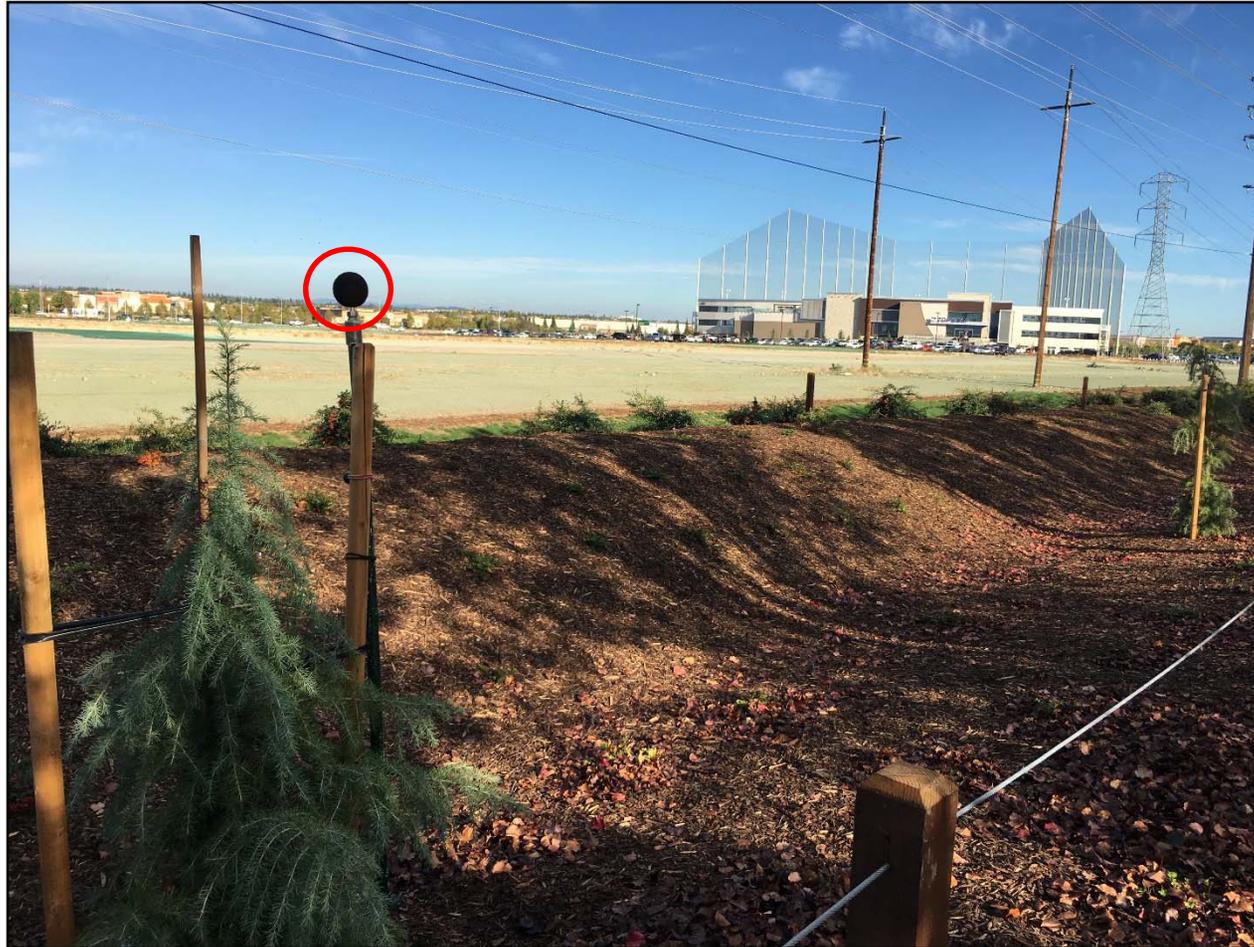
Appendix B-1
Representative TopGolf Roseville Noise Measurement Site Photographs
Site 1

Examination of the noise level data for Measurement Site 1, shown in Appendices C1 and C2, indicates that, while measured maximum noise levels exceeded the Topgolf L_{max} thresholds during various times of the day and night, those exceedances were caused by aircraft, sirens, Washington Boulevard and Highway 65 traffic, and other sources. Noise from Topgolf operations was not identified as resulting in exceedance of the L_{max} thresholds. Even during the late night hours when traffic noise levels were lower.

Microphone at end of 5 foot
PVC boom attached to tree
stake at location indicated.

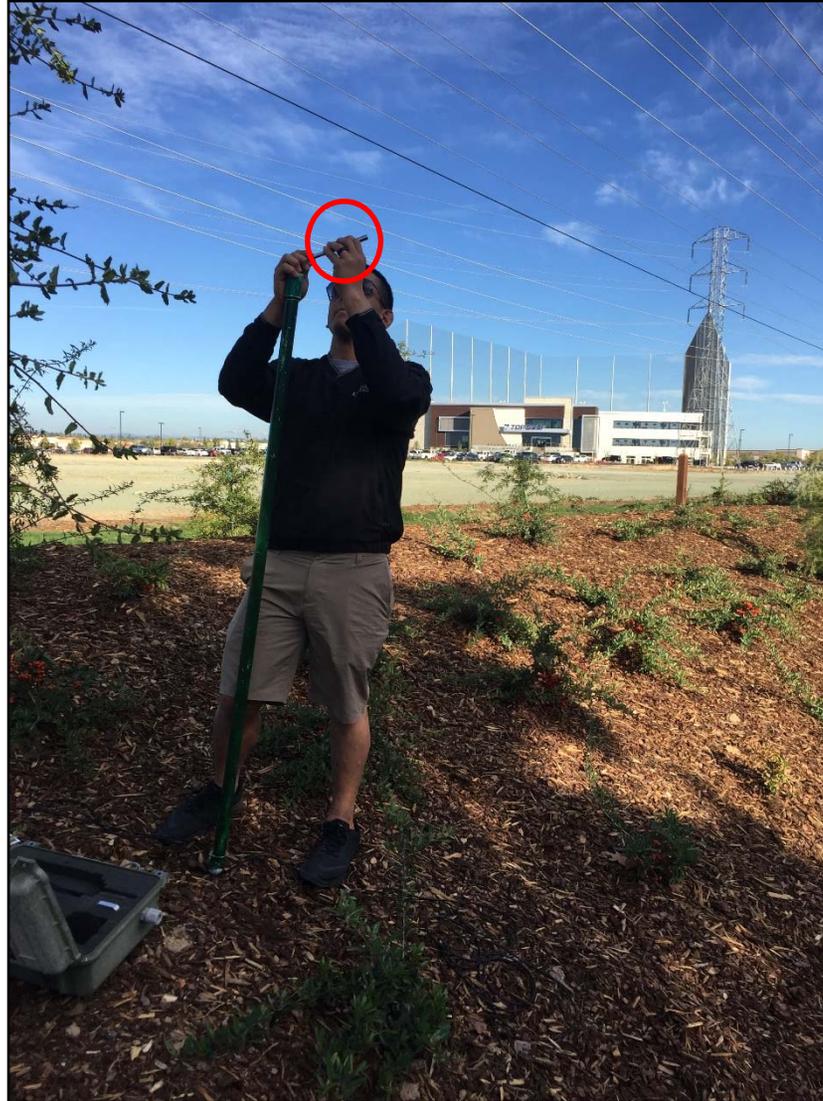
Appendix B-2
TopGolf Roseville Noise Measurement Site Photographs
Site 2

Examination of the noise level data for Measurement Site 2, shown in Appendices C3 and C4, indicates that, while measured maximum noise levels exceeded the Topgolf L_{max} thresholds during various times of the day and night, those exceedances were caused by aircraft, sirens, Washington Boulevard and Highway 65 traffic, and other sources. Although not the main noise source, noise from Topgolf operations was identified as resulting in an exceedance of the 60 dB L_{max} standard during a brief period of Topgolf patrons talking in raised voices in the parking lot area around 10:15 pm on Saturday. The measured exceedance was 5 dB above the noise level standard.

Measured average noise levels at Site 2 were also above the Topgolf L_{eq} thresholds from approximately 10 pm on Friday night, but not on Saturday night. However, BAC staff observations conducted during the late-night hours indicated that noise from Topgolf music and patrons was virtually inaudible at measurement Site 2 during the late-night hours (with the exception of the noted maximum noise standard exceedance noted above). Observed average noise levels resulting from Topgolf operations were below the City's noise thresholds applied to the project at measurement site 2.

Microphone at end of 5 foot
PVC boom ultimately
attached to tree stake.

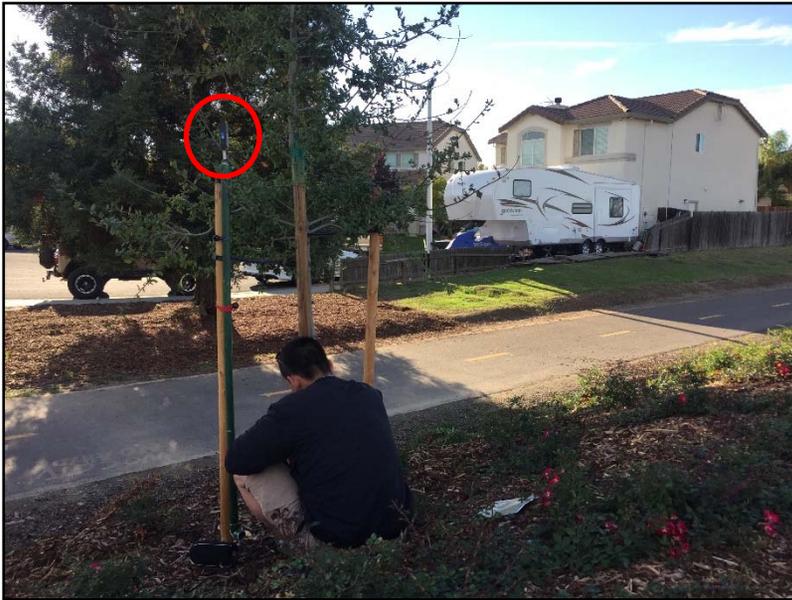
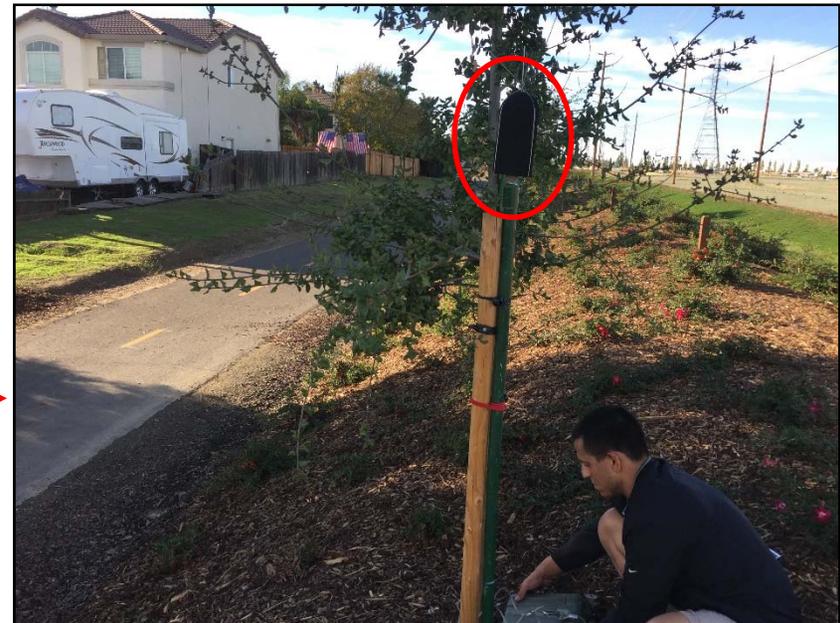
Appendix B-3
TopGolf Roseville Noise Measurement Site Photographs
Site 3

Measurement Site 3 was located closest to the main Topgolf parking area, but was shielded from view of the open drive bays. Examination of the noise level data for Measurement Site 3, shown in Appendices C5 - C7, indicates that, while measured maximum noise levels exceeded the Topgolf L_{max} thresholds during various times of the day and night, those exceedances were caused by aircraft, sirens, Washington Boulevard and Highway 65 traffic, and other sources. Although not the main noise source, noise from Topgolf operations was identified as resulting in an exceedance of the 60 dB L_{max} standard during a brief period of Topgolf patrons talking in raised voices in the parking lot area around 10:15 pm on Saturday. This is the same exceedance which was identified at measurement Site 2. The measured exceedance was 7 dB above the noise level standard at measurement Site 3.

Microphone at end of 5 foot
PVC boom – photo shows
calibrator attached during
setup.

Microphone at end of 5 foot
PVC boom – both photos
shows Mr. Armenta's
residence in background.

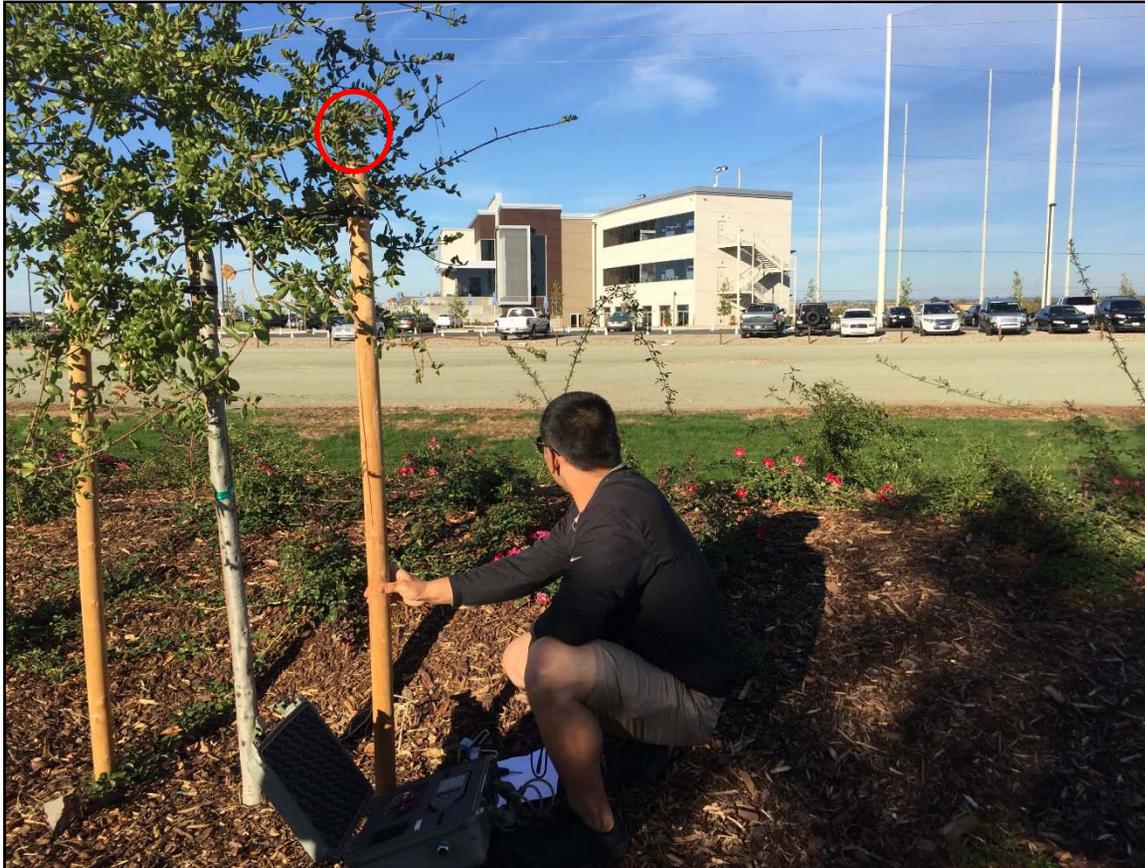
Appendix B-4
TopGolf Roseville Noise Measurement Site Photographs
Site 4

Measurement Site 4 was located at the closest point to the Topgolf structure, but the open driving range bays were blocked from view by the structure. Examination of the noise level data for Measurement Site 4, shown in Appendices C8 and C9, indicates that, while measured maximum noise levels exceeded the Topgolf L_{max} thresholds during various times of the day and night, those exceedances were caused by aircraft, sirens, Highway 65 traffic, local traffic and other sources not attributable to Topgolf operations. Maximum noise levels from Topgolf operations were identified as being within compliance with the project's maximum noise level standards at Site 4.

Microphone ultimately placed at end of 5 foot PVC boom attached to tree stake at location indicated. Mic not yet installed when this photo taken.

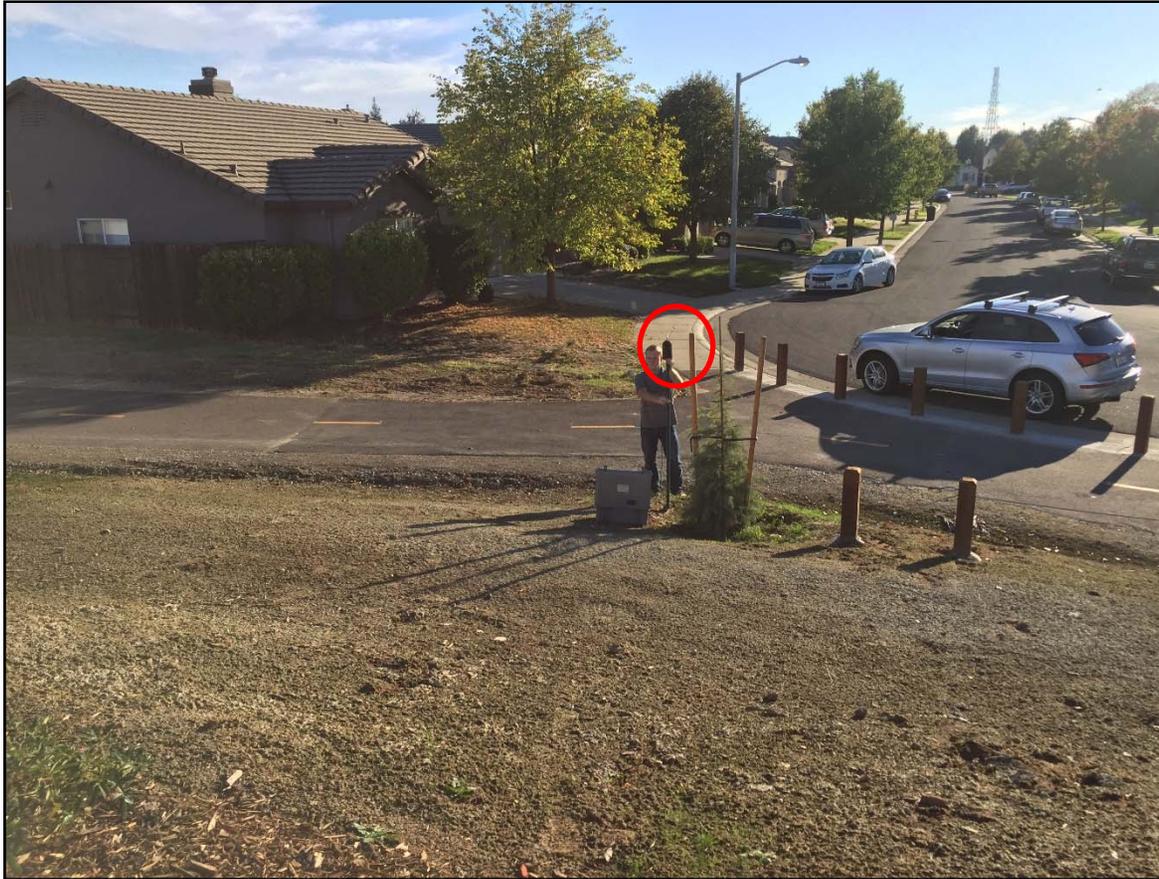
Appendix B-5
TopGolf Roseville Noise Measurement Site Photographs
Site 5

Microphone ultimately placed
at end of 5 foot PVC boom
attached to tree stake at
location indicated.
